AUTHORIZING THE APPROVAL OF THE FINAL REPORT ON THE WATER LINE LEAK DETECTION PROJECT AT THE RED RIVER ARMY DEPOT

Final Report

Water Line Leak Detection Project for:
Riverbend Water Resource District
at
Red River Army Depot, Texarkana, TX

Project Dates:
06/01/2016 through 06/17/2016

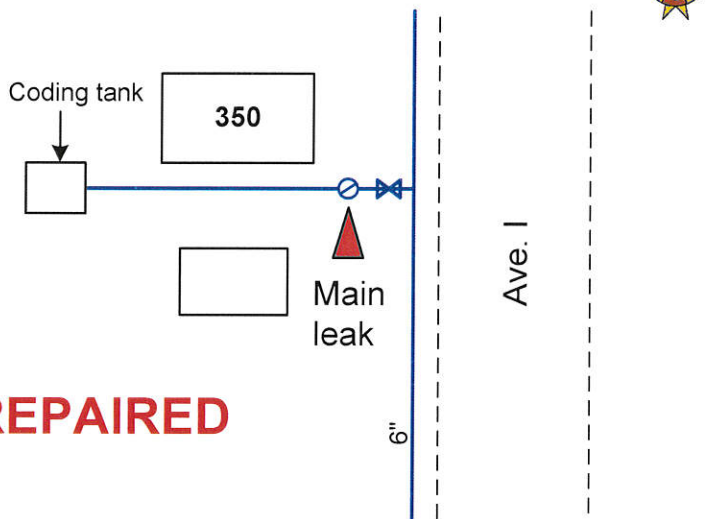
Location: Ave. I at Building #350
 Map #: _____ GPS: _____
 Remarks: Leak on 2" main line feeding the diesel engine test cooling towers. Leak is fixed.
 Leak Type: Main
 Recommendations: Repaired

REPAIRED

Leak Consultant: BC
 Leak No: 1
 Leak Class: II
 Leak Rate: 15 GPM
 Cover Type: Soil
 Site Marked: No
 Date: 06/17/16
 Job No: 16201

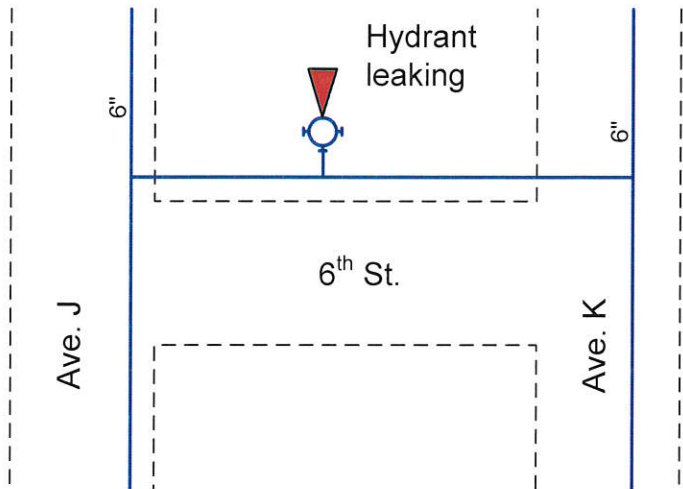
Location: 6th St. Between Ave. J and Ave. K
 Map #: _____ GPS: _____
 Remarks: Fire hydrant leaking on 6th St. between Ave. J and Ave. K.
 Leak Type: Hydrant
 Recommendations: Repair / Replace

Leak Consultant: BC
 Leak No: 2
 Leak Class: III
 Leak Rate: .25 GPM
 Cover Type: Soil
 Site Marked: No
 Date: 06/13/16
 Job No: 16201

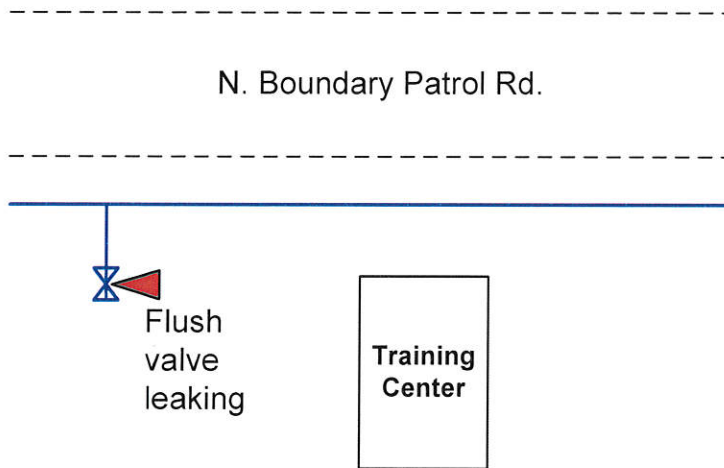
Location: N. Boundary Patrol Rd at Training Center
 Map #: _____ GPS: _____
 Remarks: Flush valve leaking. This flush valve is usually flushing 24/7 but was turned off for survey purposes. Still leaking.
 Leak Type: Valve
 Recommendations: Repair / Replace

Leak Consultant: BC
 Leak No: 3
 Leak Class: III
 Leak Rate: 1 GPM
 Cover Type: Soil
 Site Marked: No
 Date: 06/13/16
 Job No: 16201

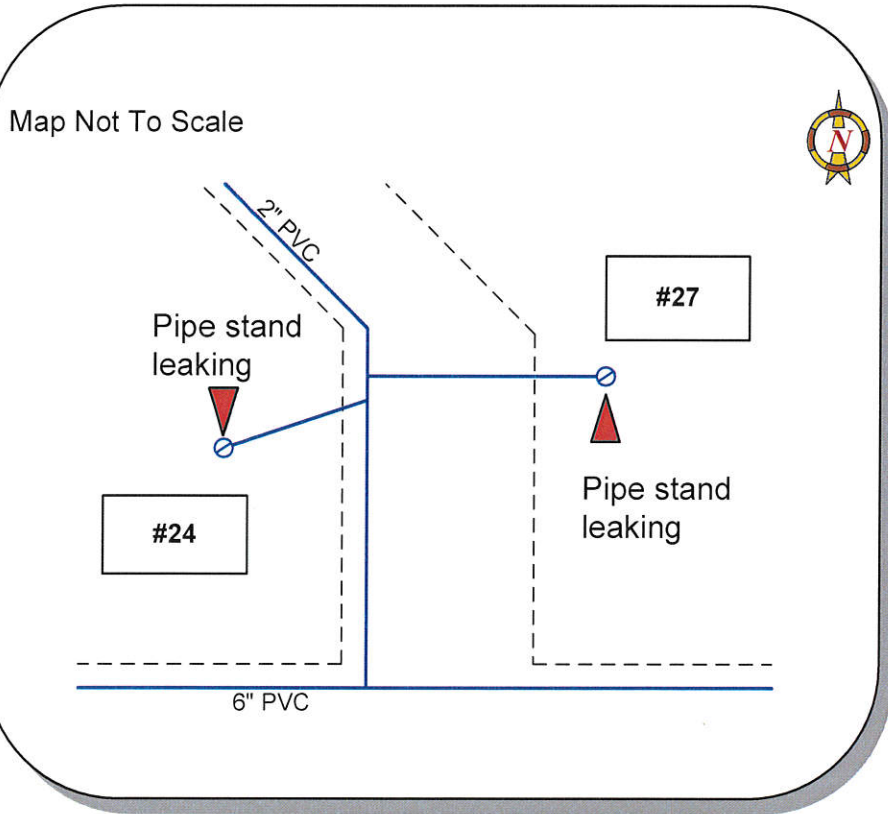
Location: Elliot Lake Rd. Campground #24 and #27
 Map #: _____ GPS: _____
 Remarks: Pipe stands for campground water hook ups are leaking.
 Leak Type: Pipe stands
 Recommendations: Repair / Replace

Leak Consultant: BC
 Leak No: 4
 Leak Class: III
 Leak Rate: 2 GPM
 Cover Type: Soil
 Site Marked: No
 Date: 06/13/16
 Job No: 16201
